Manhole Inspection Summary

Manhole # S27M1_010MH

Insp Date: **2/22/08 12:41 PM**

Location Address: **2700 Giles Road**

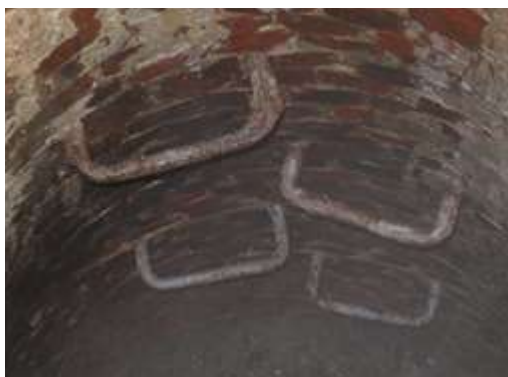
Defect 2

Condition: ☒ Sound ☐ Cracked ☐ Root Intrusion ☐ Deteriorated ☐ Leaks ☐ Debris

Channel

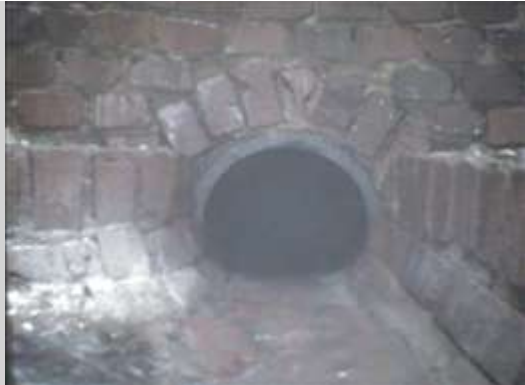
12 O'Clock Outflow

10 in. Circular Gravity Sewer
Pipe Out @ 12 O'Clock

Pipe Height: **9.6** (in.) Rod and Bar (Angled)
Pipe Material: **Clay** ☐ Pipe Lined
Invert Depth: **9.68** (ft.) Flow Characteristics: **Fast**
Deposits: ☒ None ☐ Mud ☐ Sludge ☐ Debris ☐ Grease
Silt Depth: (in.) Deposits Extent:
Infiltration: **None** Pipe Seal Cond: **Sound**

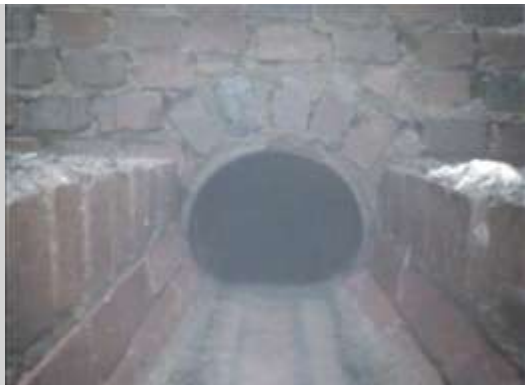
6 O'Clock Inflow

10 in. Circular Gravity Sewer
Pipe In @ 6 O'Clock

Pipe Height: **9.6** (in.) Rod and Bar (Angled)
Pipe Material: **Clay** ☐ Pipe Lined
Invert Depth: **9.54** (ft.) Flow Characteristics: **Fast**
Deposits: ☒ None ☐ Mud ☐ Sludge ☐ Debris ☐ Grease
Silt Depth: (in.) Deposits Extent:
Infiltration: **None** Pipe Seal Cond: **Sound**

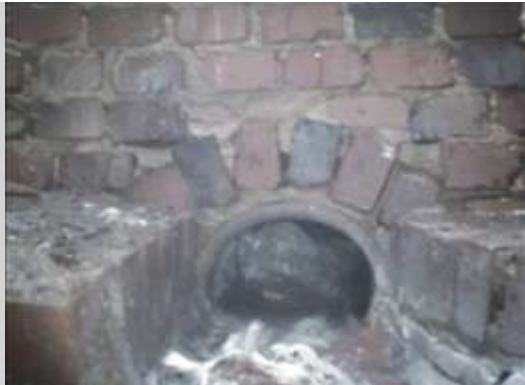
9 O'Clock Inflow

8 in. Circular Gravity Sewer

Pipe In @ 9 O'Clock

Infiltration: **None** Pipe Seal Cond: **Sound**
